North Shore Streamkeepers
Final Report
Water Quality and Watershed
Health of MacKay Creek, 2007-
2009 Study

March 31, 2009

**North Shore Streamkeepers
MacKay Creek Watershed Study
Photo Report, 2007 – 2009**

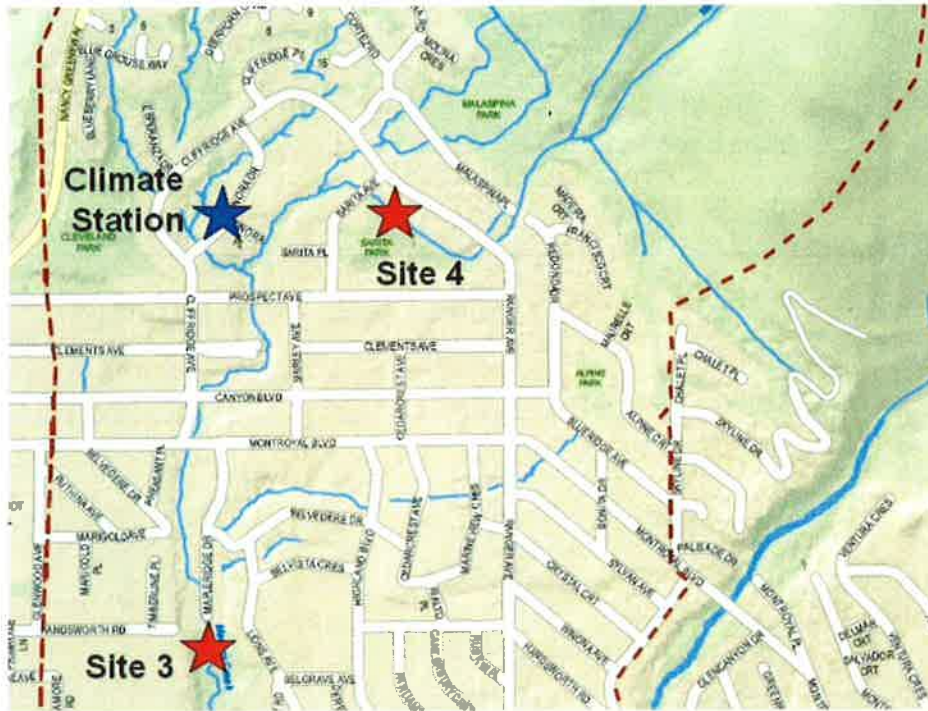
Figure 4: Location of Sites 3 and 4 and the Sonora Drive Climate Station, MacKay Creek, 2007-2008

Site 3: MacKay Creek above Ridgewood Drive (in Upper MacKay Creek Park, in a forested ravine surrounded by a low density residential area). Site 3 is shown in Figure 4.

Site 4: MacKay Creek at Ranger Avenue (in the headwaters, upstream of most residential land). The location is shown in Figure 4.

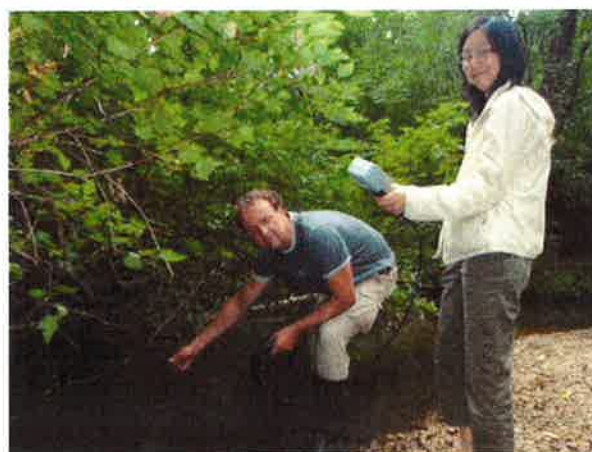
Figure 6: Sampling crew using the YSI meter at Site 1

Figure 6 shows the YSI meter in use.

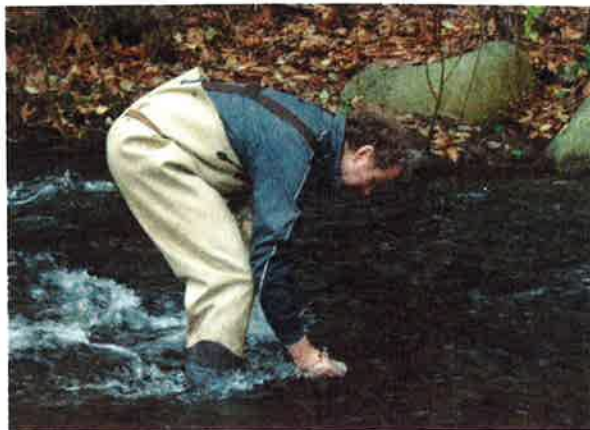
Figure 7: Filling of sample bottles midstream at Site 2

In situ data were collected first, using the YSI meter. Subsequently, three sampling bottles were filled at each site for bacteria, metals and anions/nutrients. Figure 7 shows the filling of a sample bottle.

All the measurements and water samples were collected in the middle of the creek, in fast running flow to avoid stagnant areas where the water could be altered. Care was taken to avoid contamination during sampling, by following defined protocols (preventing contact with the insides of bottles and lids, keeping the samples refrigerated to stop bacterial development).

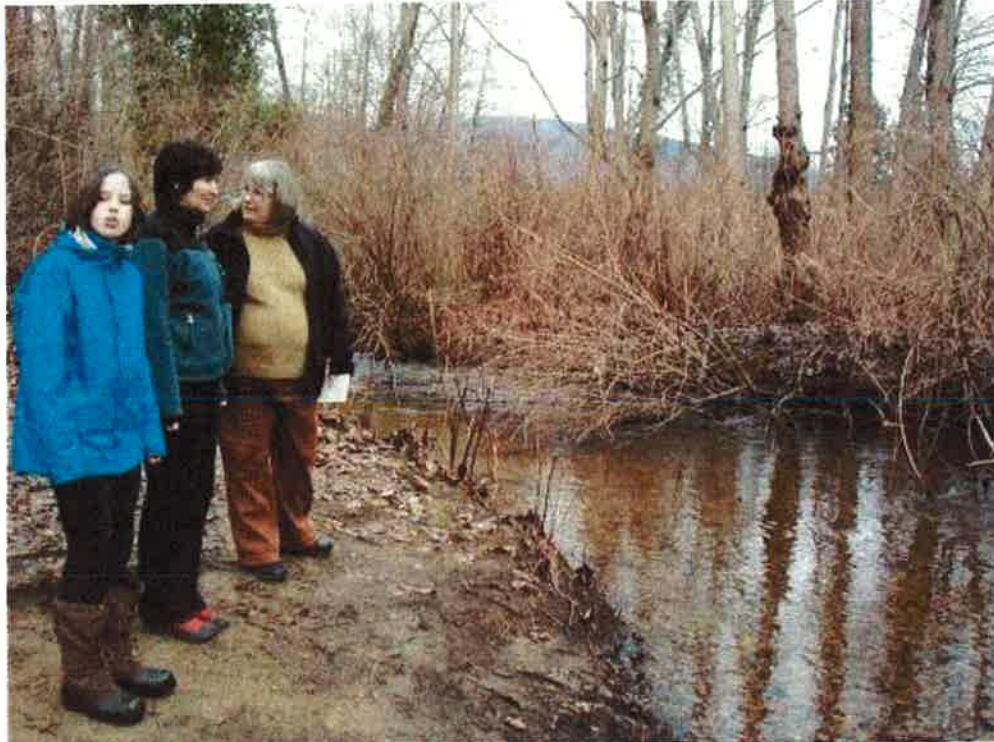
Photo1 Mackay Site 1, January 2008, low water. This site is in the lower watershed in MacKay Creek Park, with industrial and commercial activities nearby. Margaret Phelan, Environment Canada Project Liaison, joined us.

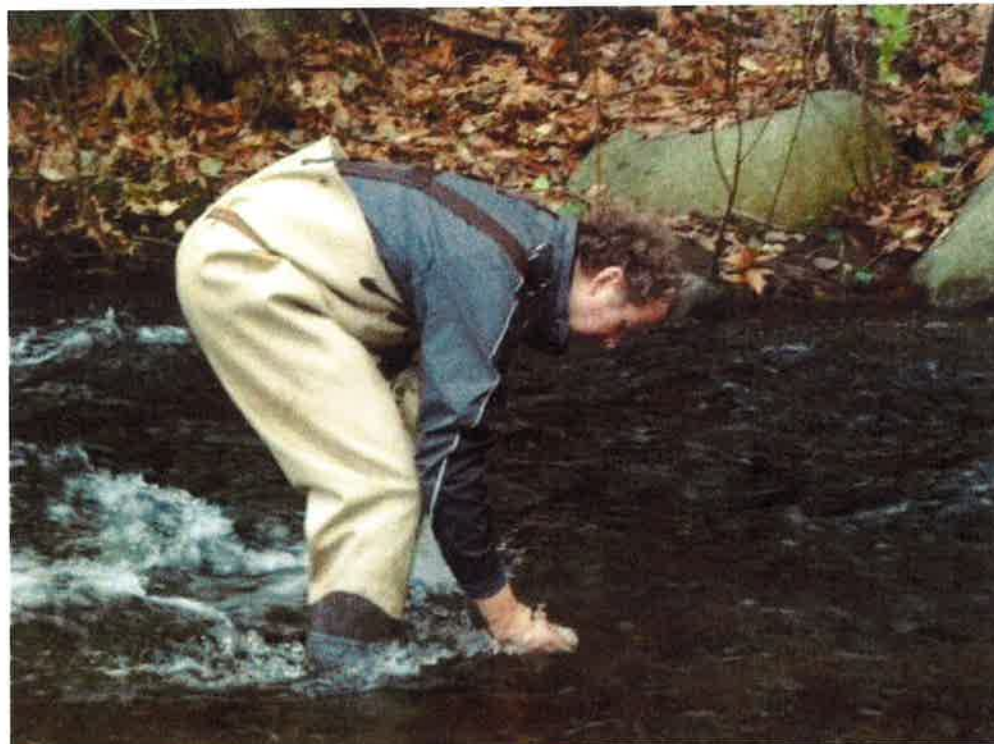
Photo 2 MacKay Site 2, March 2008, in Heywood Park collecting a water sample. This site is downstream of residential areas.

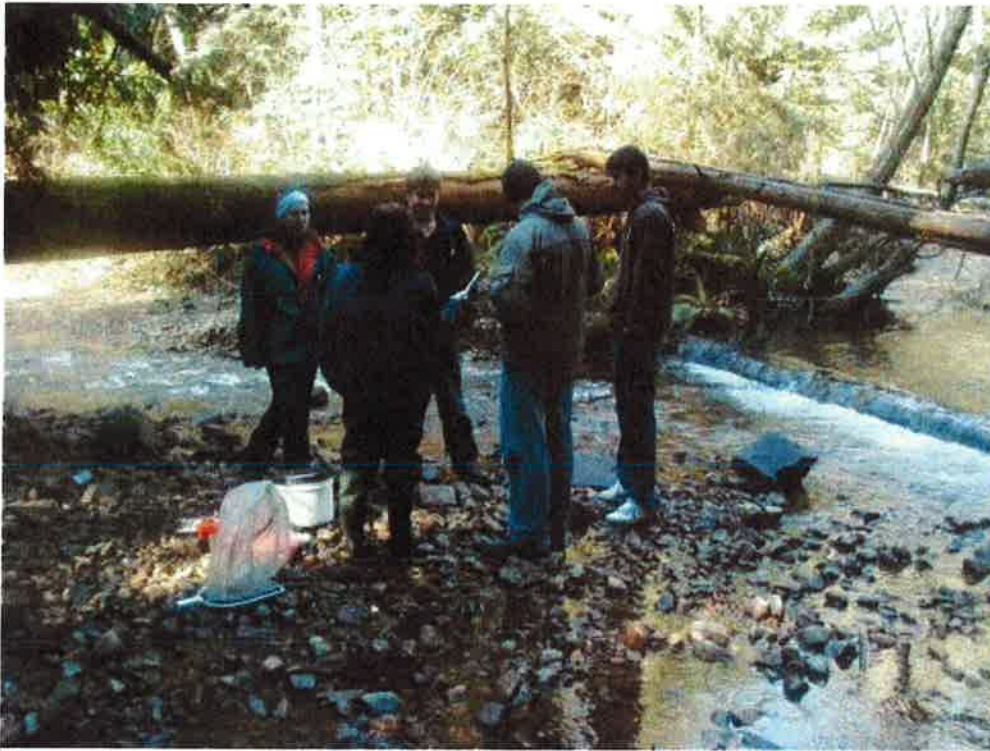
Photo 3 MacKay Site 3, February 2008, is in the ravine upstream of Edgemont Village. UBC students helped collect water and benthic invertebrate samples. High quality fish and wildlife habitat in the ravine is threatened by spread of invasive plants and recreational use.

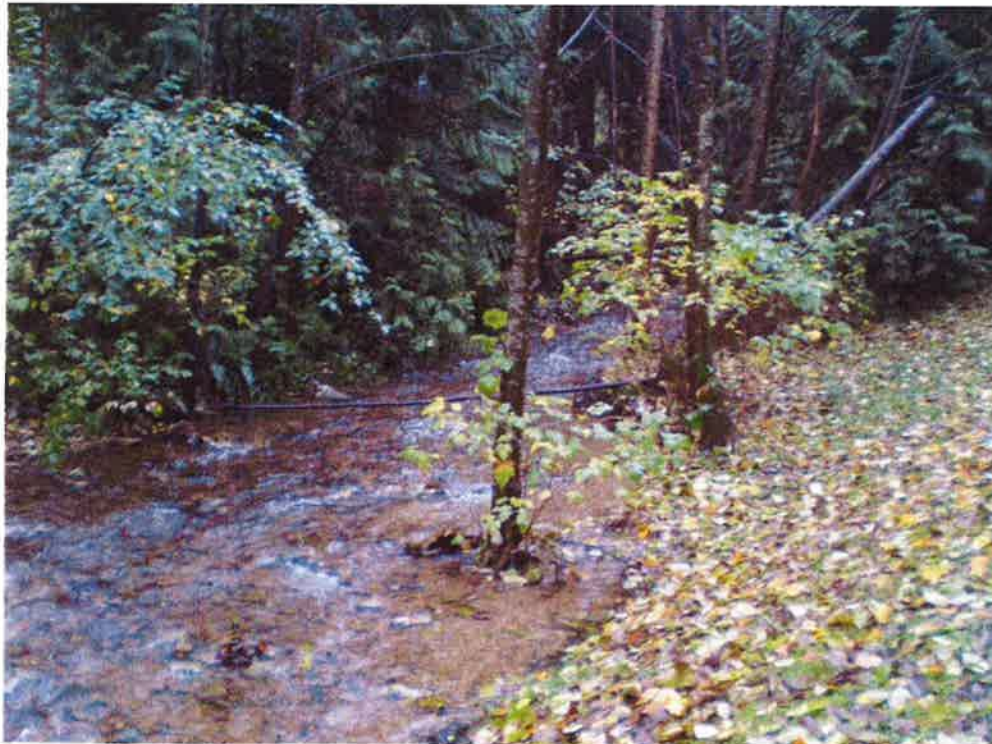
Photo 4 MacKay Site 4, is in a headwater tributary in Sarita Park, above most of the residential development. The flows year round and supports trout.

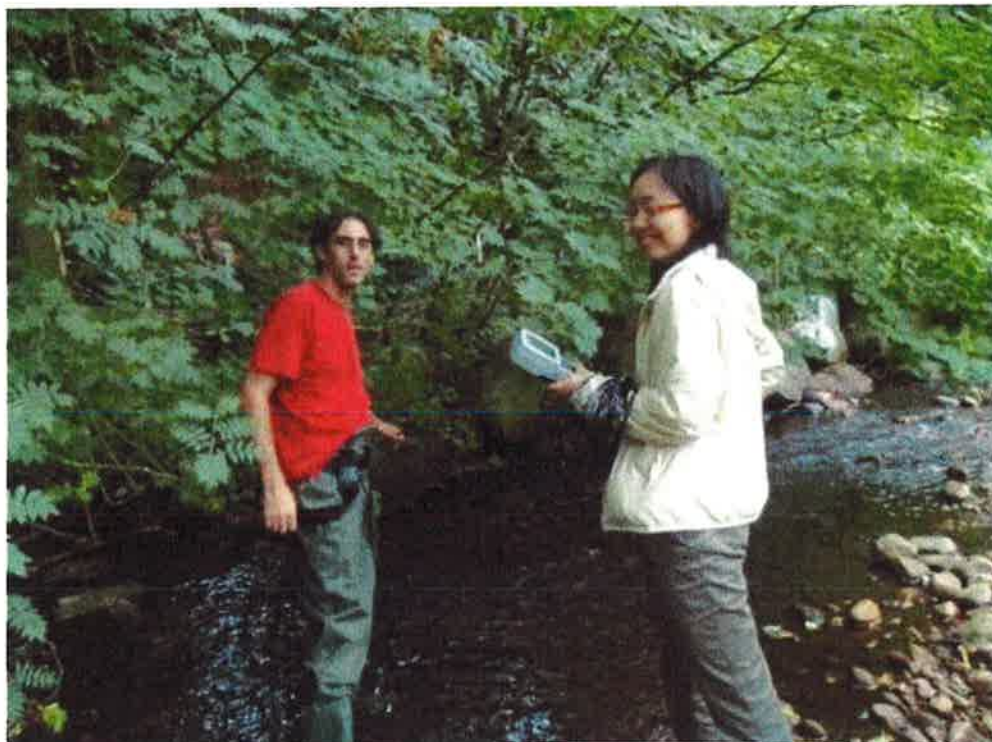
Photo 5 Using the YSI meter to measure water temperature, pH, dissolved oxygen and conductivity, August 2008 at MacKay Site 2. Britta Ng from District of North Vancouver joined us.

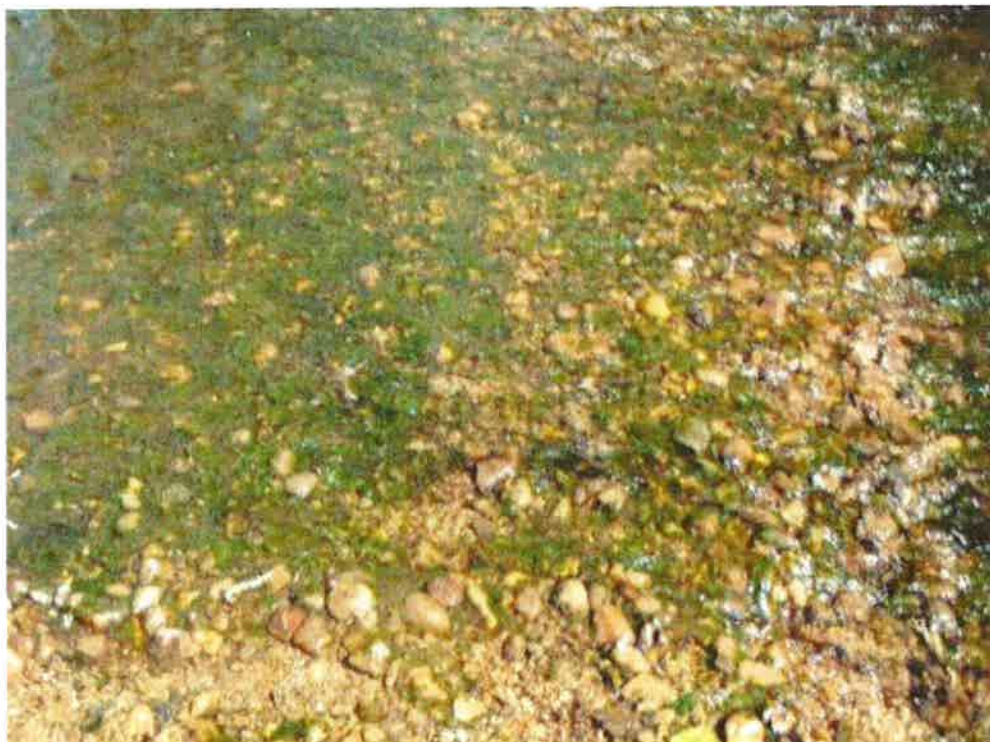
Photo 10 Filamentous green algae growth was common at all sites in the spring.

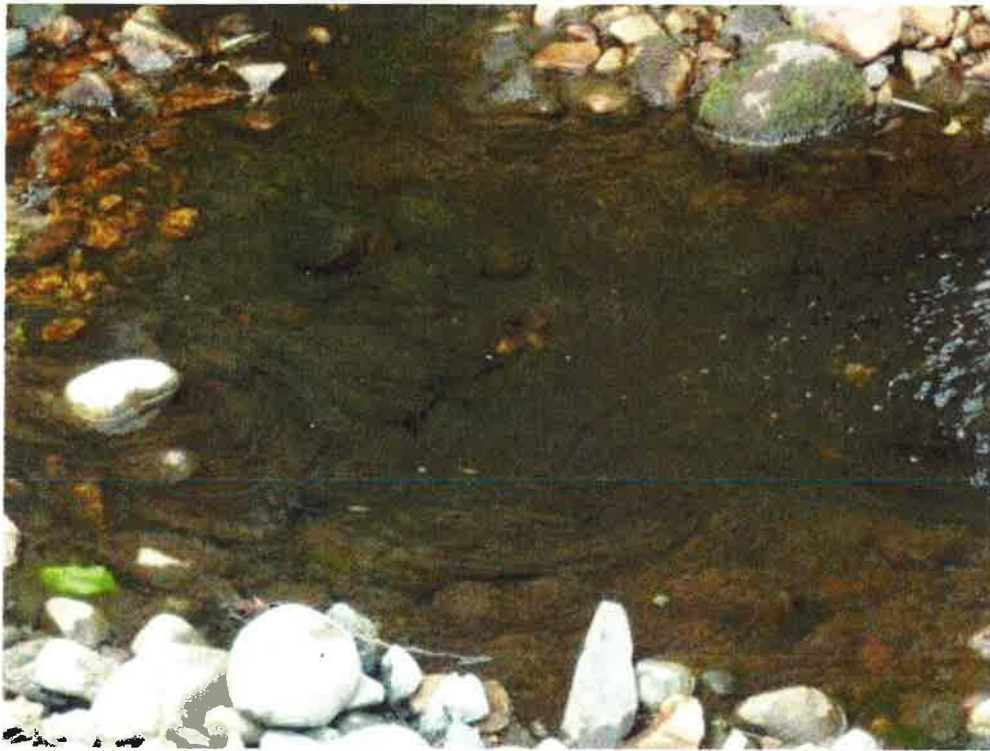
Photo 11 Dense algae growth (diatoms) was present in summer, reflecting relatively high nutrient loads (up to 0.012 mg/L ammonia, 0.62 mg/L nitrate and 0.006 mg/L ortho phosphate during summer).

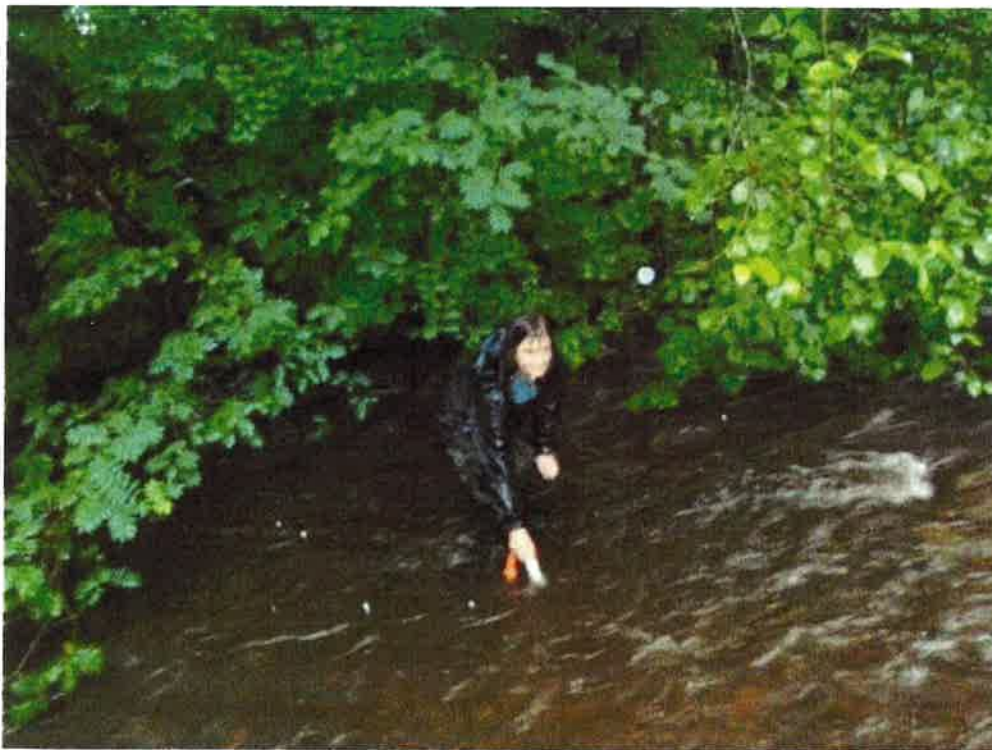
Photo 12 June 2008 – we sampled in the rain, too, when turbid water is expected, but were surprised to see such brown water at Sites 1 (above), 2 and 3.

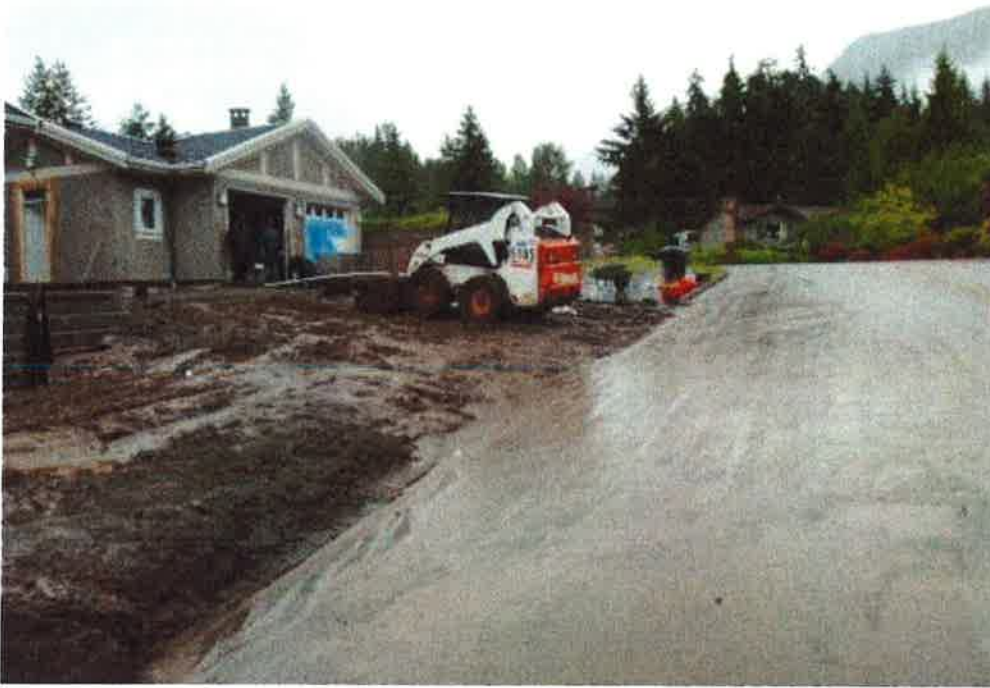
Photo 13 June – this improperly managed landscaping site was unprepared for rain and was the source of highly turbid water – 5 km of stream ran brown for several hours (total suspended solids up to 134 mg/L, turbidity of 55 NTU, well above water quality guidelines). Silt damages fish gills and clogs stream substrates.

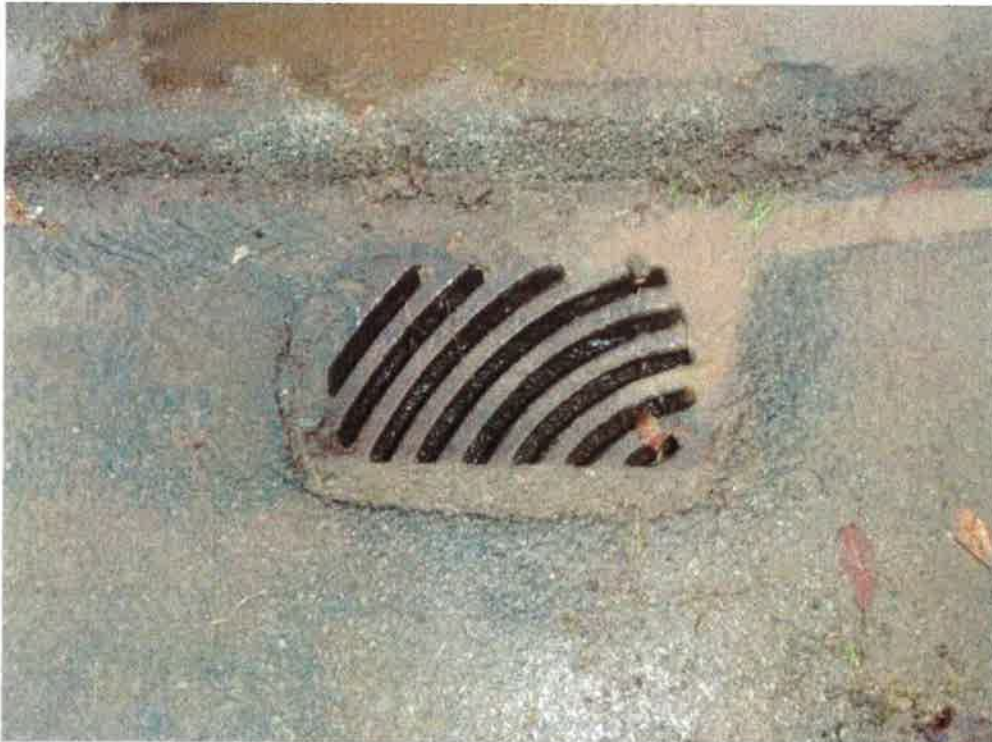
Photo 14 Storm drains are the main pathways for pollutants from road runoff to enter a stream. This was from the June rainstorm at landscape site.

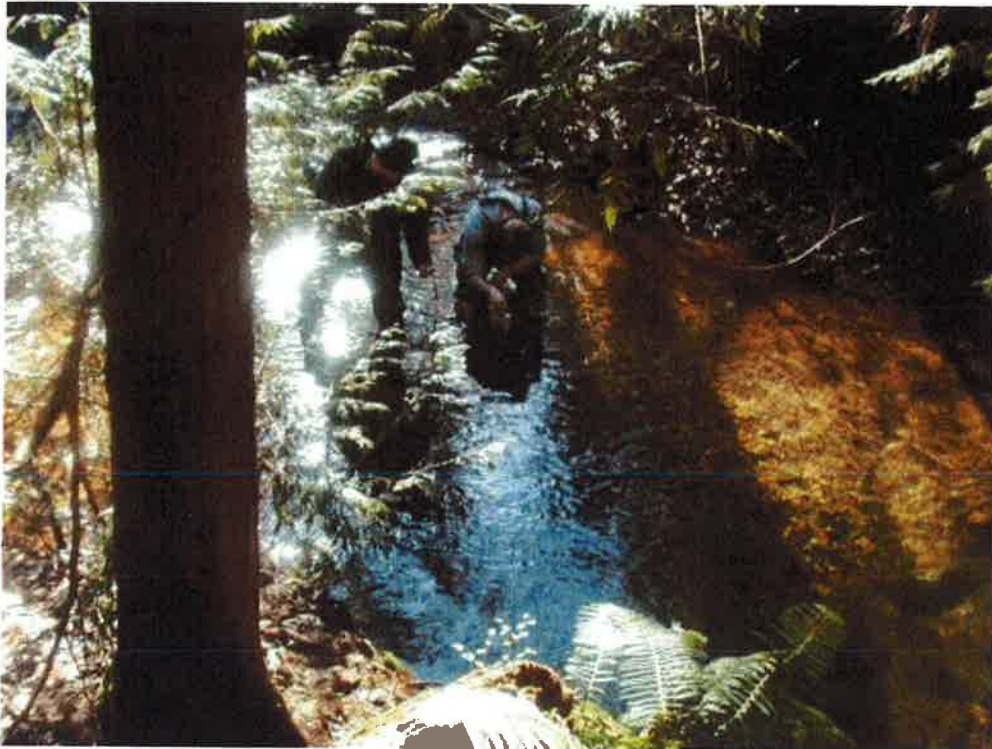
Photo 15 Fecal coliform bacteria levels were elevated at Sites 1, 2 and 3 throughout the year and were highest at Site 3 in the MacKay ravine. E. coli numbers up to 3000 (mean probable number) were reported. Potential sources are dogs, wildlife and sanitary sewer leaks.

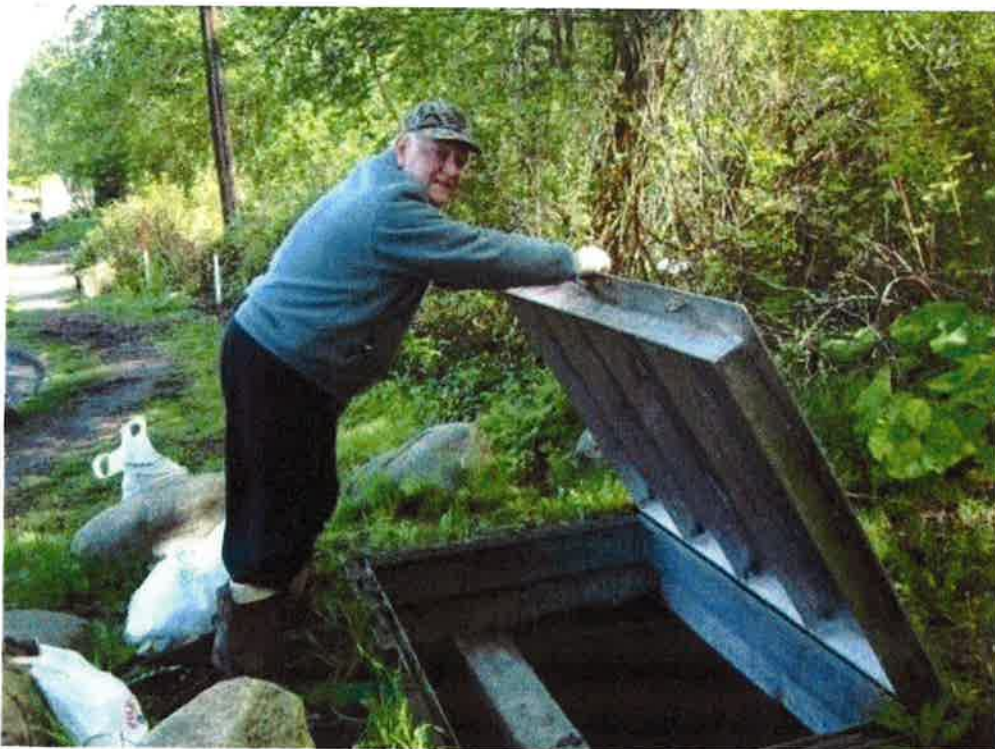
Photo 16 An oil – grit separator near Site 1, provides some treatment of road runoff in commercial and industrial area. These structures require periodic maintenance to remove accumulated oil and sediment.

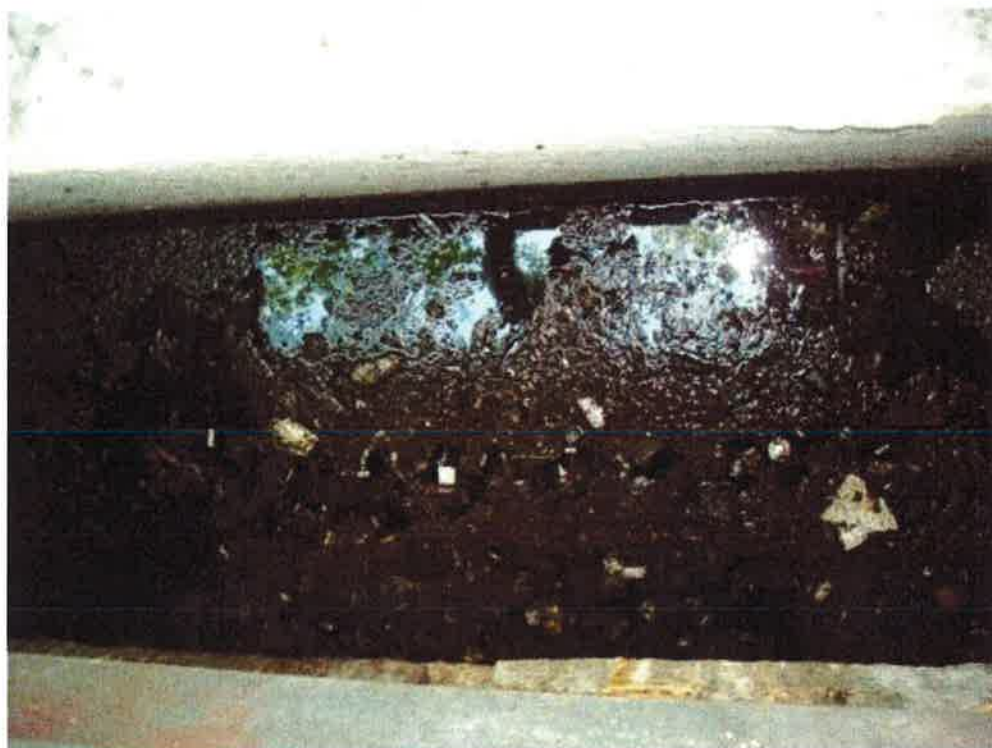
Photo 17 Inside the oil – grit separator.

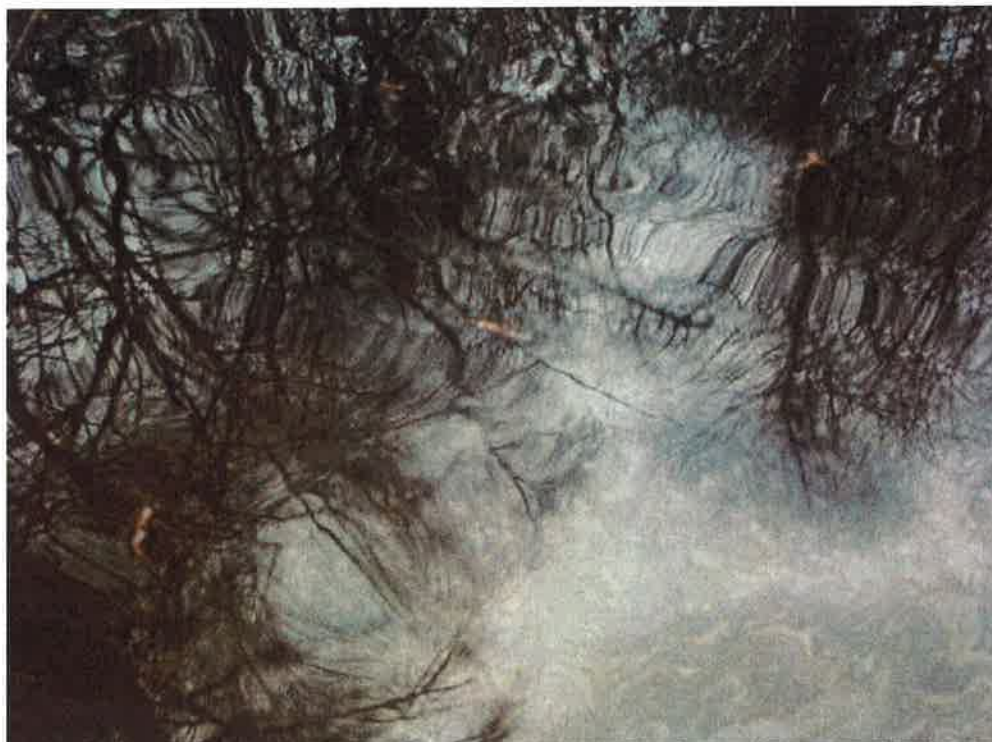
Photo 18 Oily sheens were observed on some sampling dates, especially at MacKay Site 1 (in photo), downstream of Marine Drive.

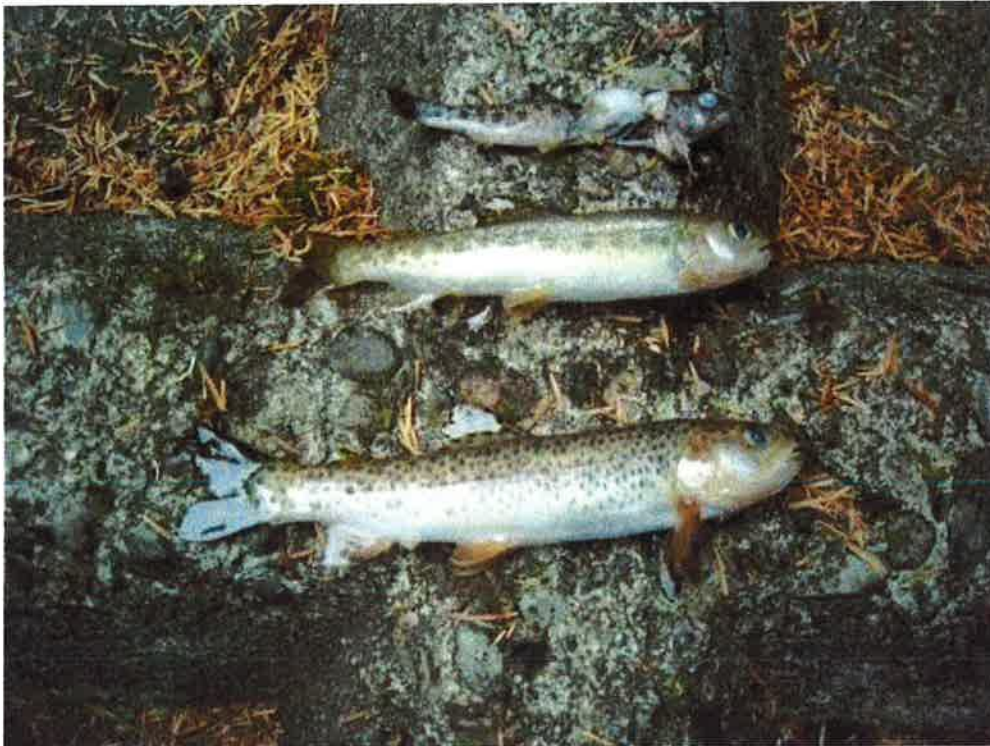
Photo 19 Evidence of a fish kill on a North Vancouver stream. Fish kills result from the discharge of toxic substances, including harsh cleaners, swimming pool and hot tub water, wash water from cement work, and other sources, either accidentally or on purpose.

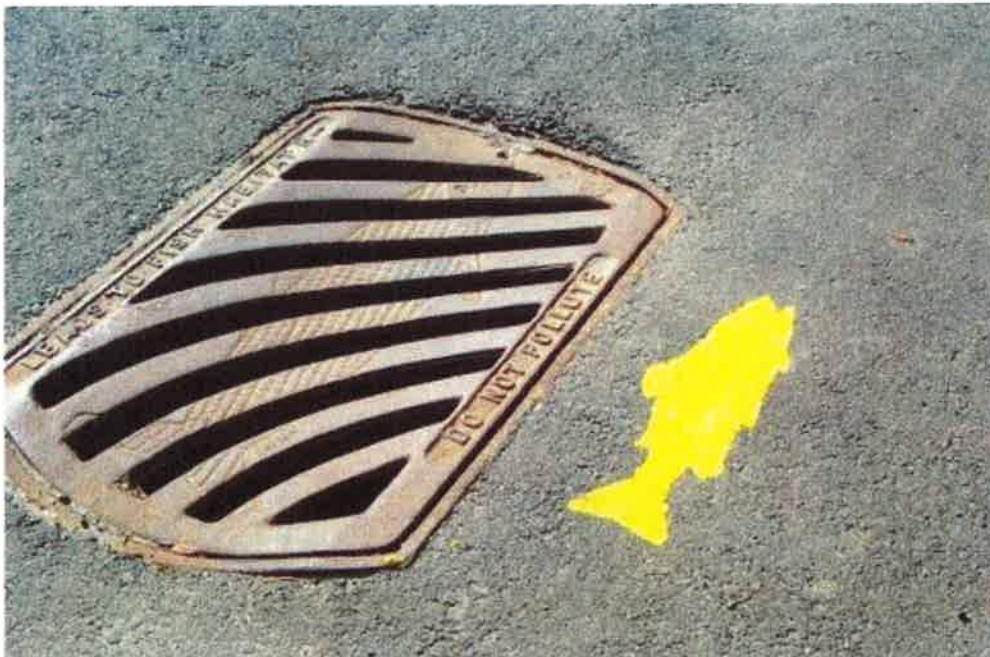
Photo 20 Storm drains lead to fish habitat in streams or the ocean. The storm drain marking program (Fisheries and Oceans Canada) encourages volunteers to paint the yellow fish to remind people about this.
