**North Shore Streamkeepers
MacKay Creek Watershed Study
Photo Report, 2007 – 2009**

March 31, 2009

Summary

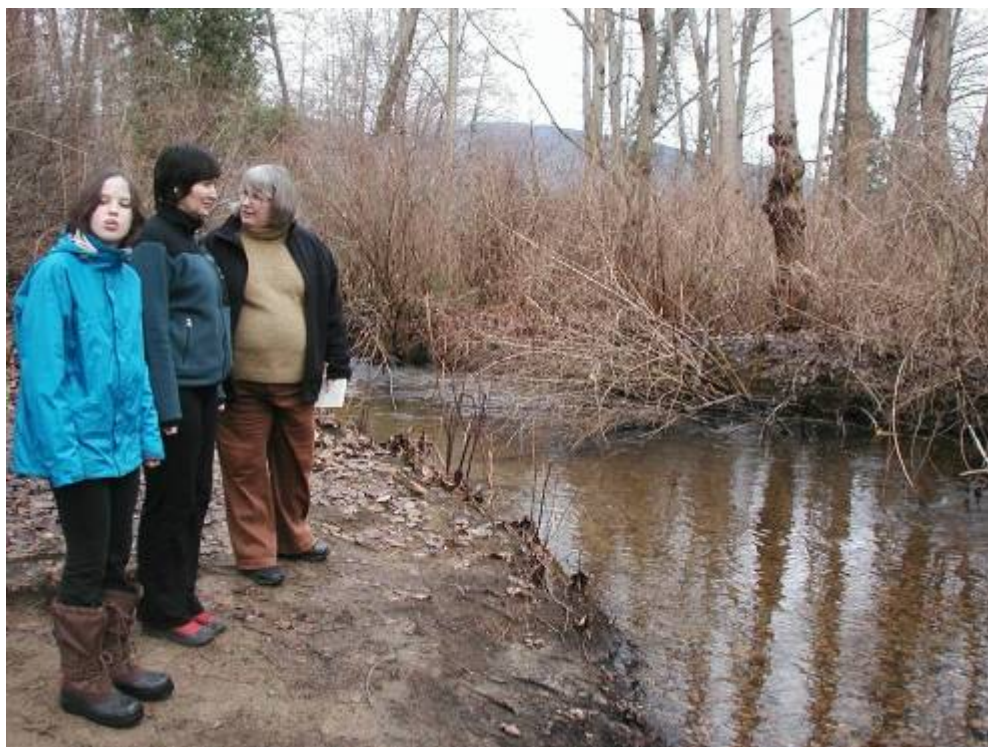
Photo1 Mackay Site 1, January 2008, low water. This site is in the lower watershed in MacKay Creek Park, with industrial and commercial activities nearby. Margaret Phelan, Environment Canada Project Liaison, joined us.

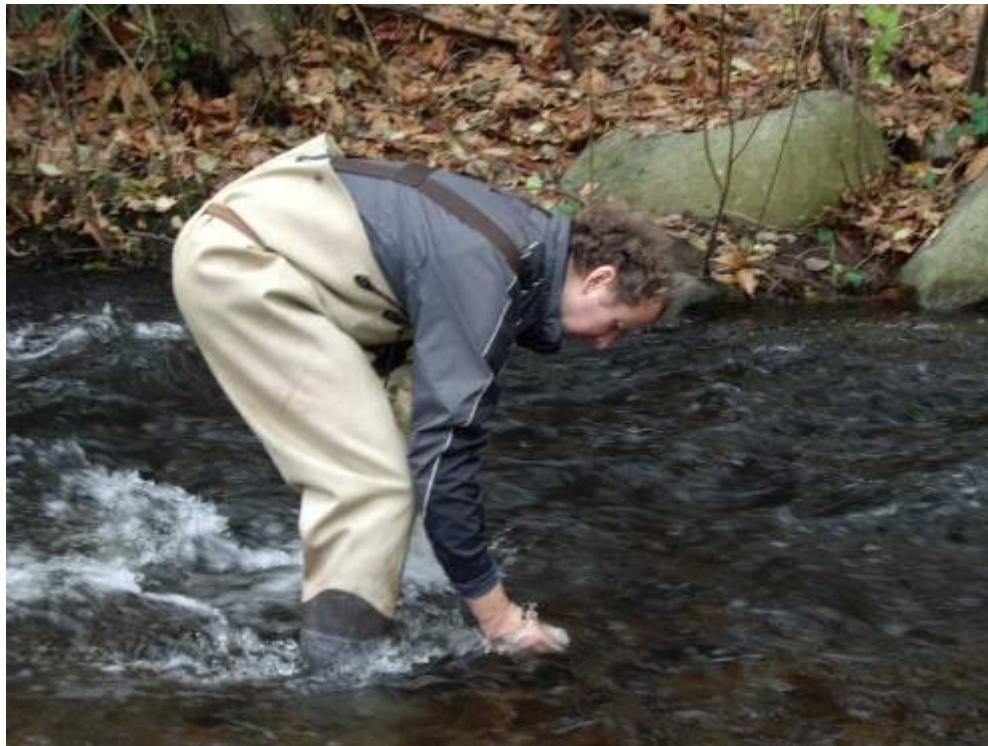
Photo 2 MacKay Site 2, March 2008, in Heywood Park collecting a water sample. This site is downstream of residential areas.

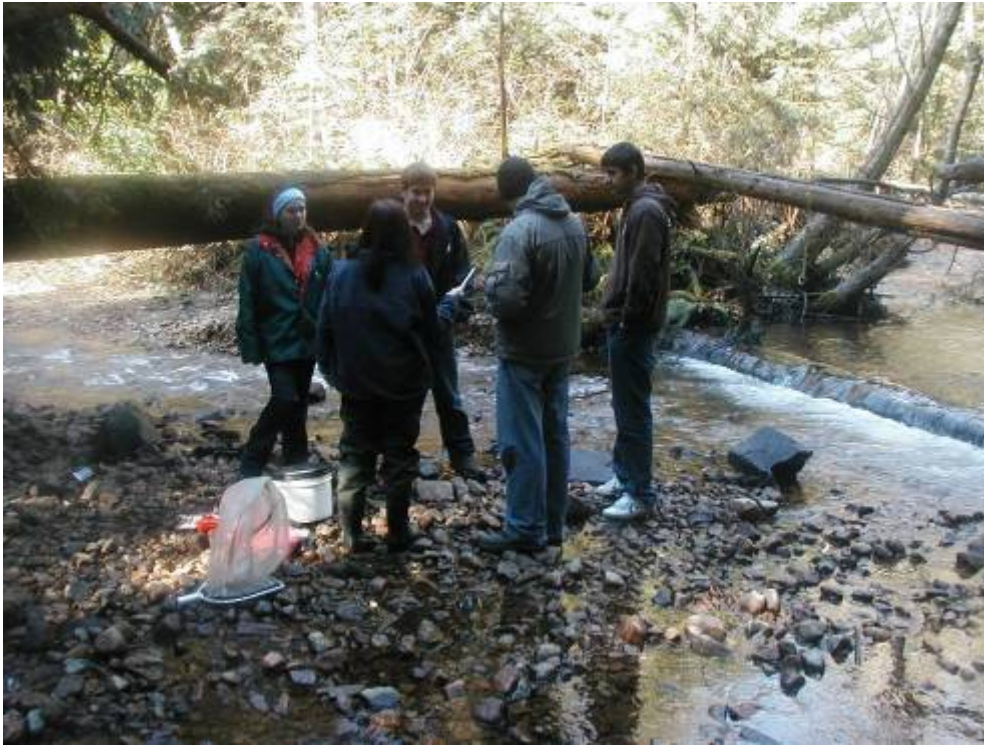
Photo 3 MacKay Site 3, February 2008, is in the ravine upstream of Edgemont Village. UBC students helped collect water and benthic invertebrate samples. High quality fish and wildlife habitat in the ravine is threatened by spread of invasive plants and recreational use.

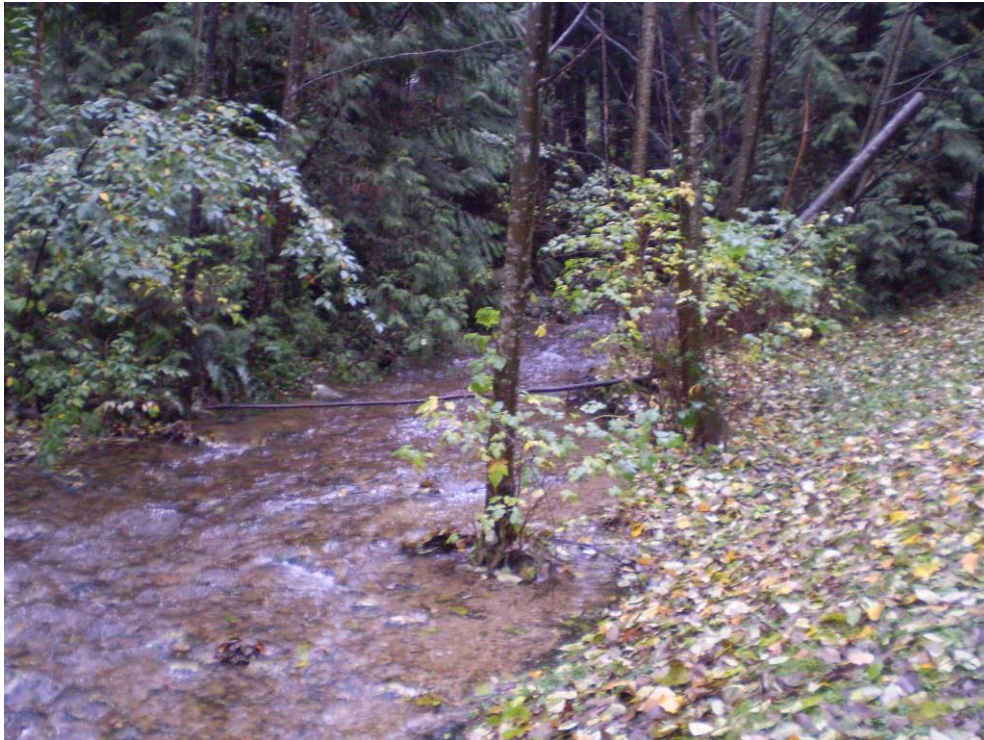
Photo 4 MacKay Site 4, is in a headwater tributary in Sarita Park, above most of the residential development. The flows year round and supports trout.

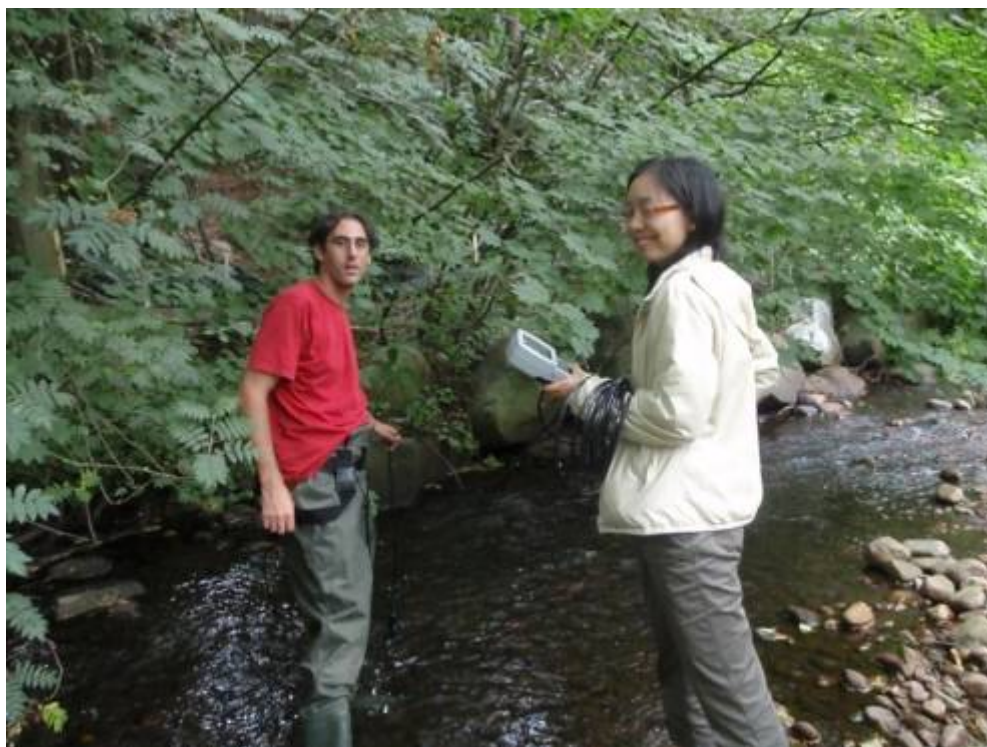
Photo 5 Using the YSI meter to measure water temperature, pH, dissolved oxygen and conductivity, August 2008 at MacKay Site 2. Britta Ng from District of North Vancouver joined us.

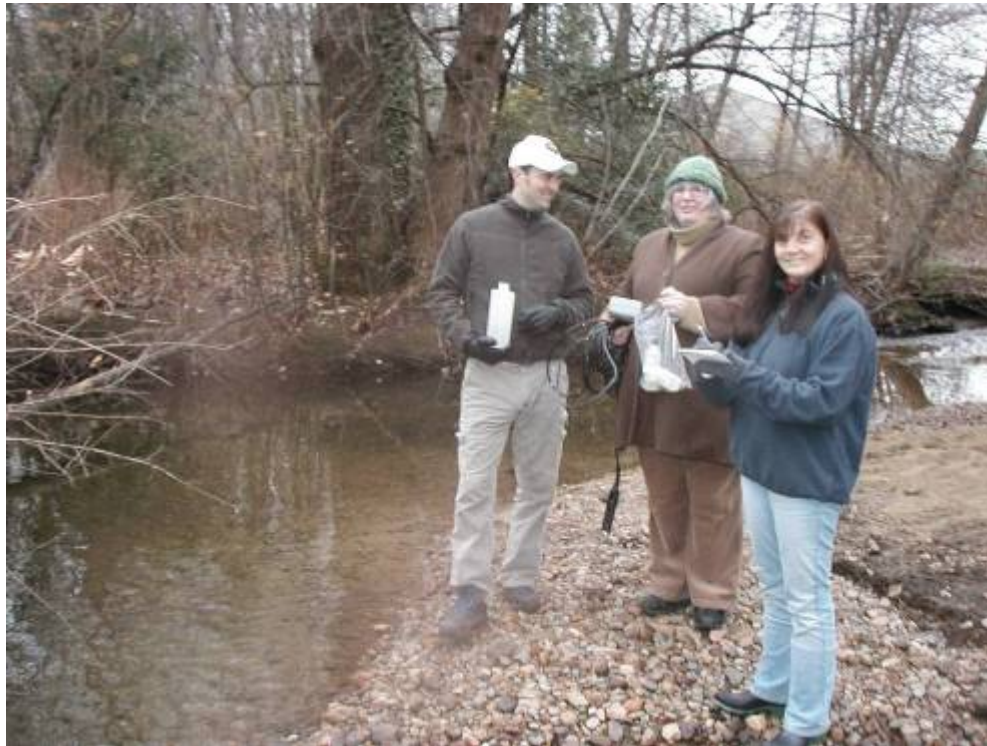
Photo 6 Preparing bottles for sampling, December 2007 at MacKay Site 1.

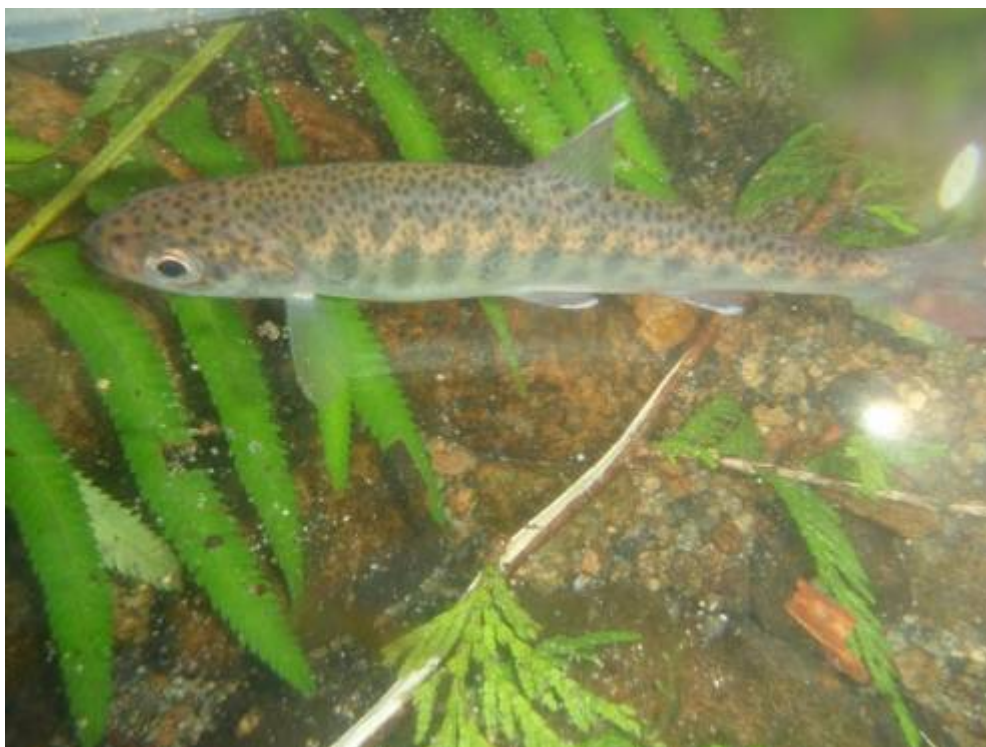
Photo 7 Cutthroat trout, coho and chum salmon are common in MacKay Creek. The upper limit of salmon distribution is just upstream of Site 3, due to instream barriers (culvert and flood repair works).

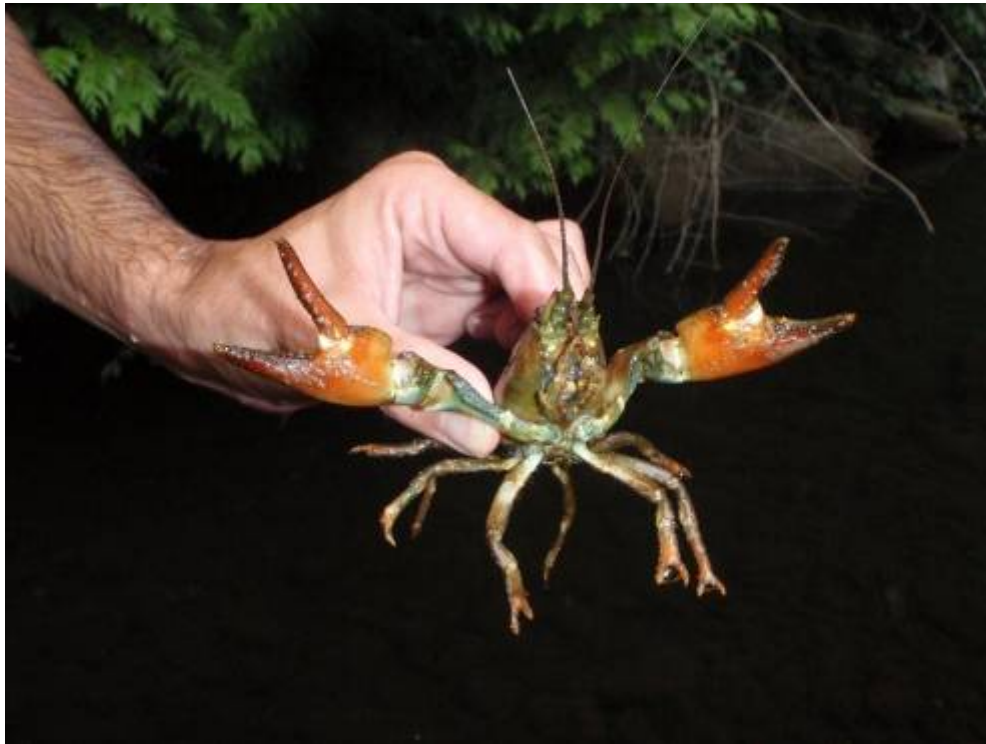
Photo 8 Crayfish inhabit the stream and are considered a sign of good water quality.

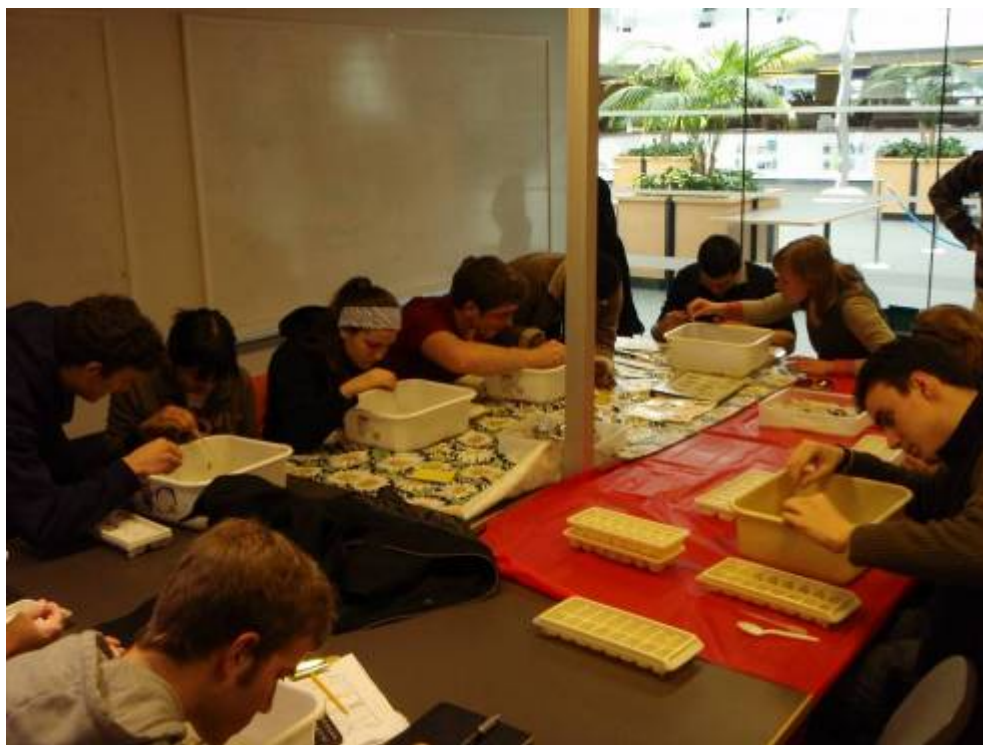
Photo 9 Benthic invertebrates were collected in September 2007 and February 2008 (see photo 3). UBC students assisted in sample sorting in February. Benthic communities provide information about stream health.

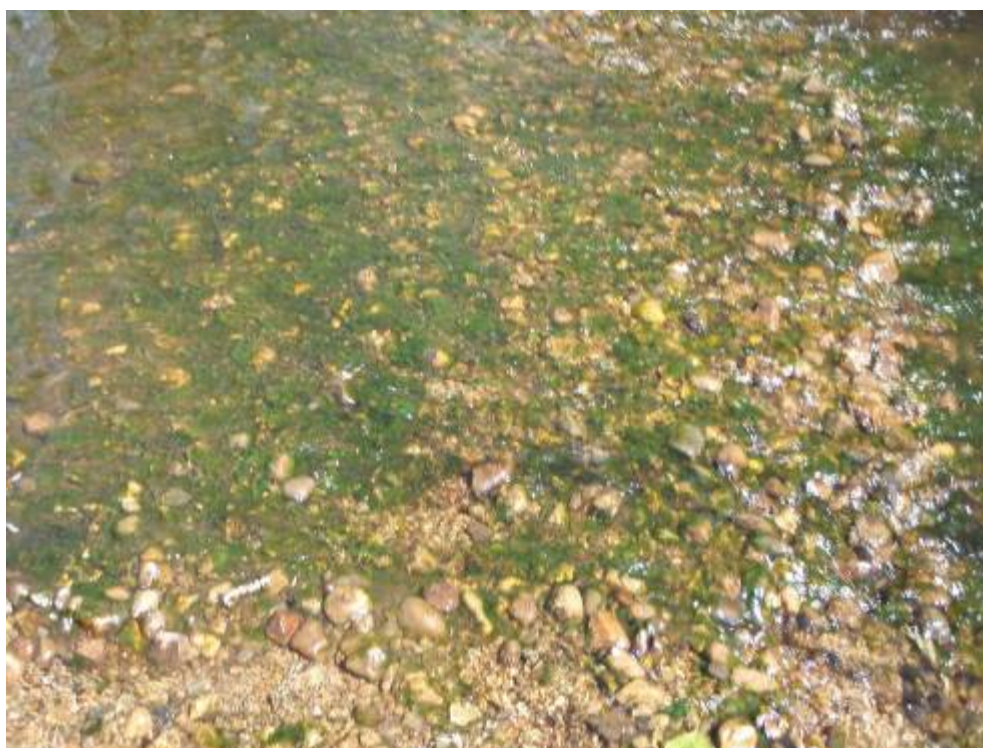
Photo 10 Filamentous green algae growth was common at all sites in the spring.

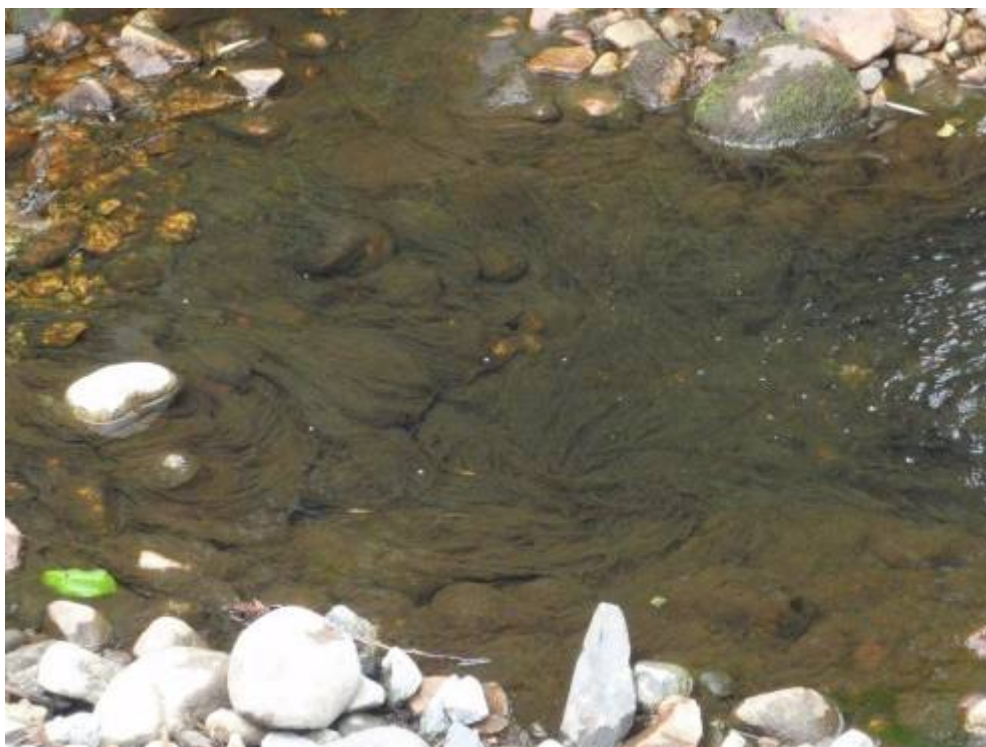
- elevated nutrient levels (up to 0.012 mg/L ammonia, 0.62 mg/L nitrate and 0.006 mg/L ortho phosphate during summer), also indicated by extensive algal growth

Photo 11 Dense algae growth (diatoms) was present in summer, reflecting relatively high nutrient loads (up to 0.012 mg/L ammonia, 0.62 mg/L nitrate and 0.006 mg/L ortho phosphate during summer).

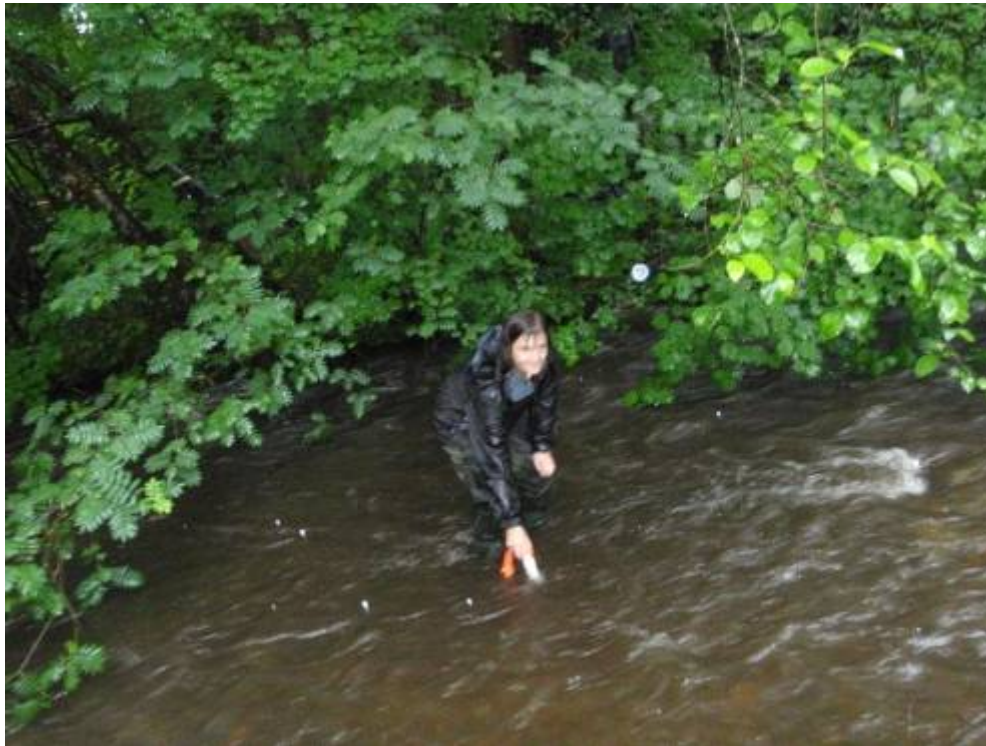
Photo 12 June 2008 – we sampled in the rain, too, when turbid water is expected, but were surprised to see such brown water at Sites 1 (above), 2 and 3.

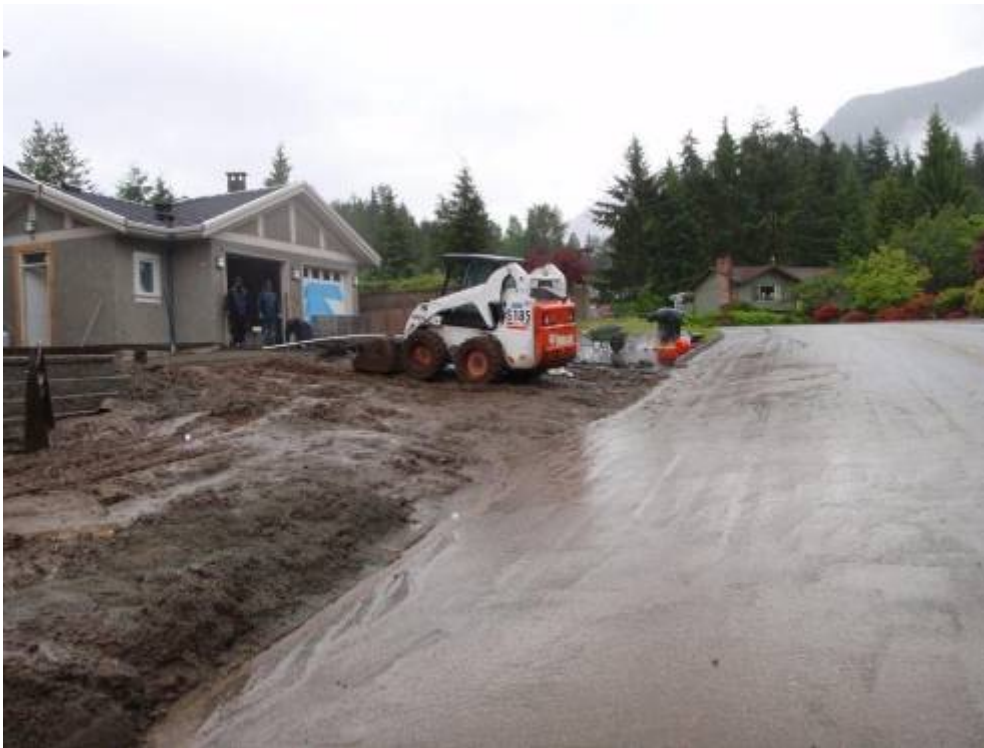
- sediment from poorly managed residential construction and landscape projects (in June, 5 km of MacKay Creek ran brown for several hours during heavy rain, total suspended solids up to 134 mg/L and turbidity of 55 NTU, well above water quality guidelines)

- metals levels within BC and CCME water quality guidelines most of the time, with exceedances noted for cadmium, copper, iron, lead and zinc during the June rainstorm, concurrent with the poorly managed landscape project in upper watershed.

Photo 13 June – this improperly managed landscaping site was unprepared for rain and was the source of highly turbid water – 5 km of stream ran brown for several hours (total suspended solids up to 134 mg/L, turbidity of 55 NTU, well above water quality guidelines). Silt damages fish gills and clogs stream substrates.

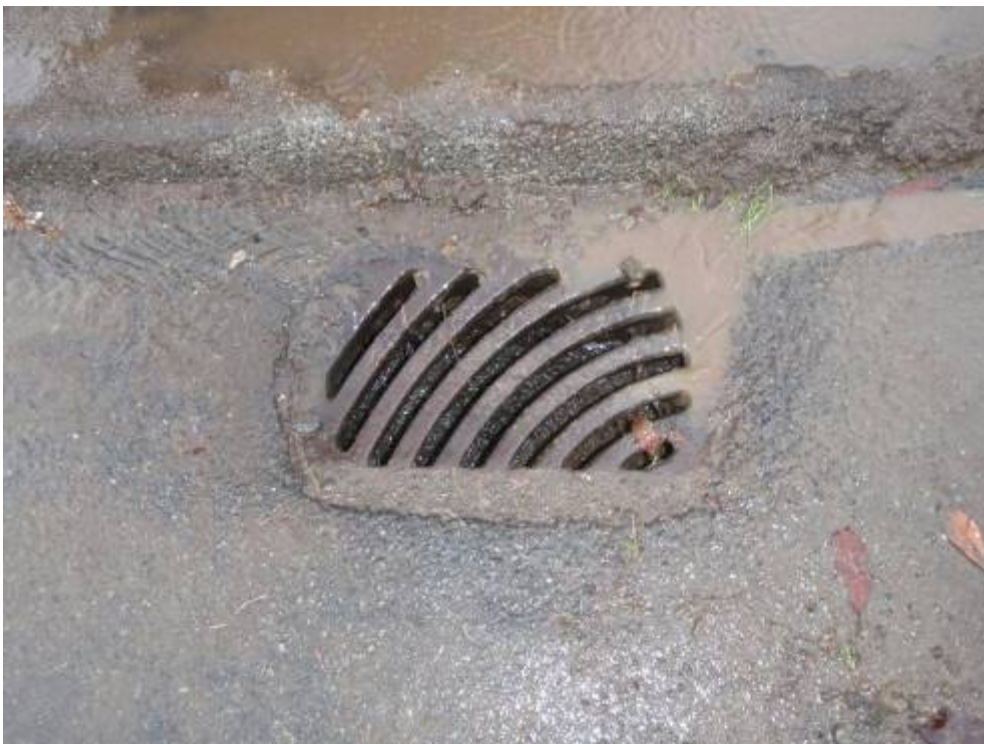
Photo 14 Storm drains are the main pathways for pollutants from road runoff to enter a stream. This was from the June rainstorm at landscape site.

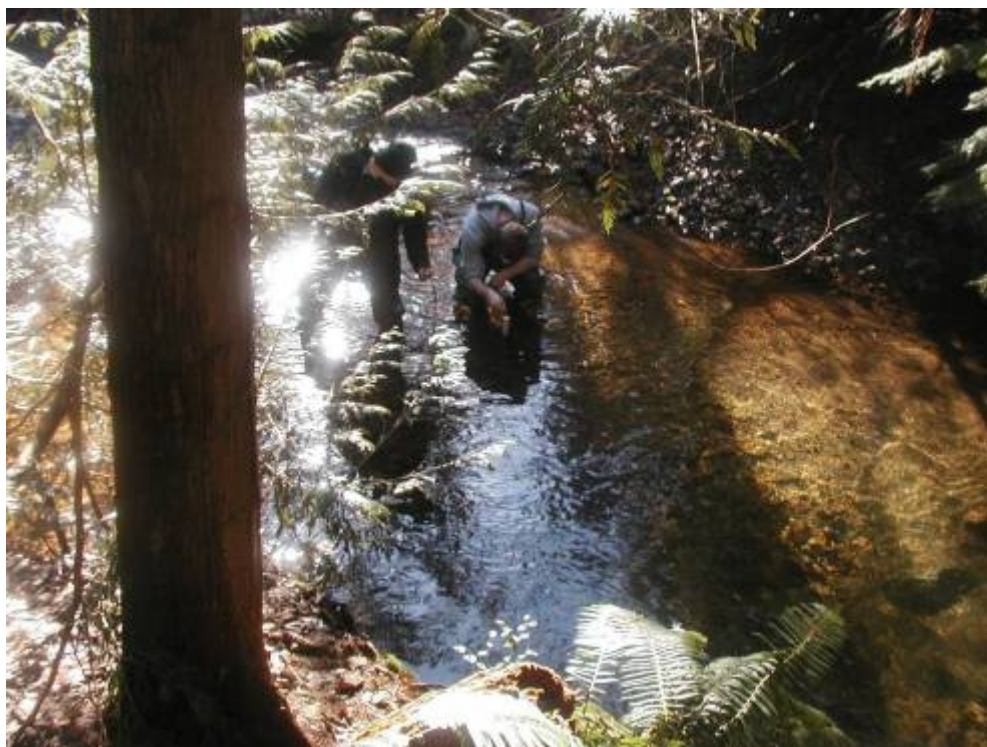
- consistently elevated fecal coliform (up to >24,000 mean probable number) and *E. coli* bacteria levels (up to 3,000 mean probable number) at Sites 1, 2 and 3, with highest numbers reported at Site 3. Dogs, wildlife and leakage from the sanitary sewers are potential sources of coliforms.

Photo 15 Fecal coliform bacteria levels were elevated at Sites 1, 2 and 3 throughout the year and were highest at Site 3 in the MacKay ravine. *E. coli* numbers up to 3000 (mean probable number) were reported. Potential sources are dogs, wildlife and sanitary sewer leaks.

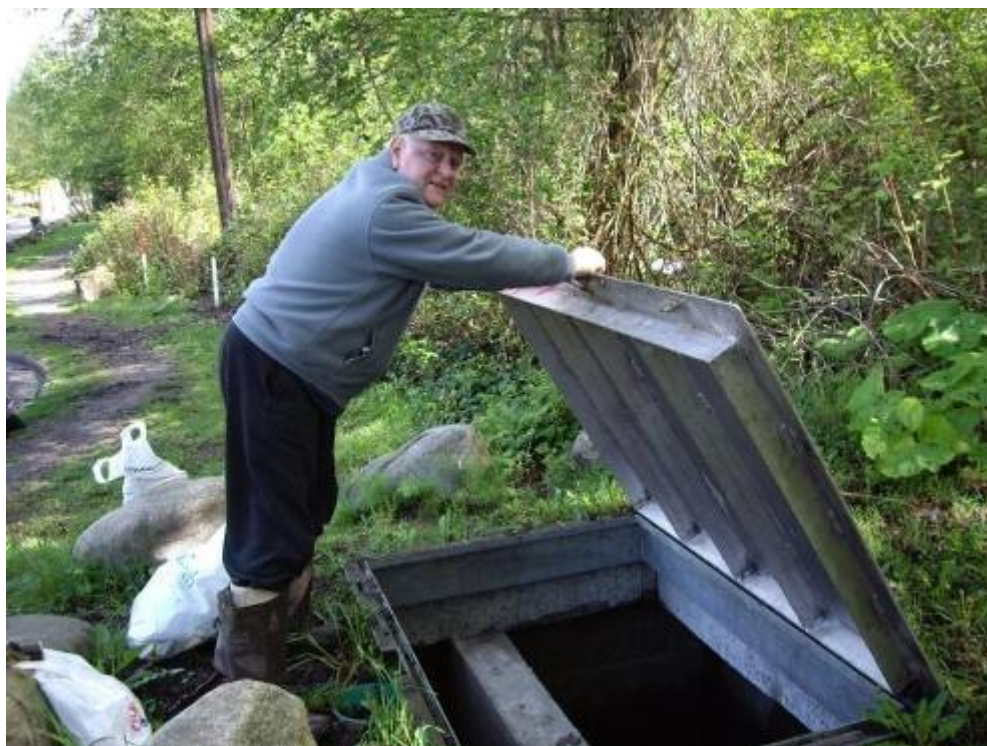
Photo 16 An oil – grit separator near Site 1, provides some treatment of road runoff in commercial and industrial area. These structures require periodic maintenance to remove accumulated oil and sediment.

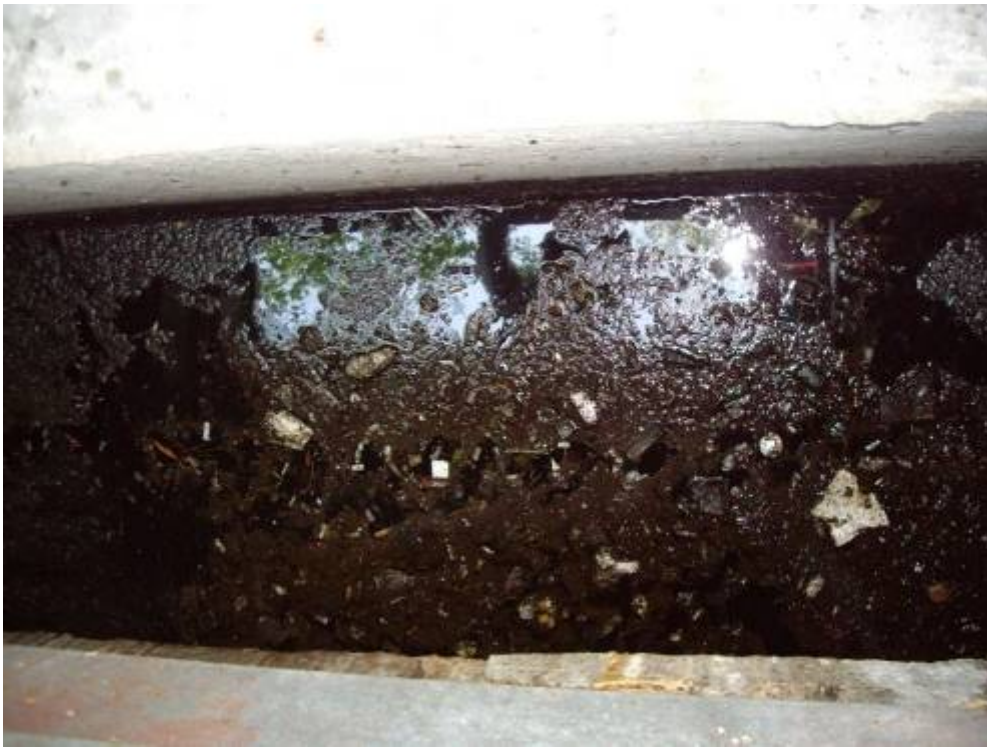
Photo 17 Inside the oil – grit separator.

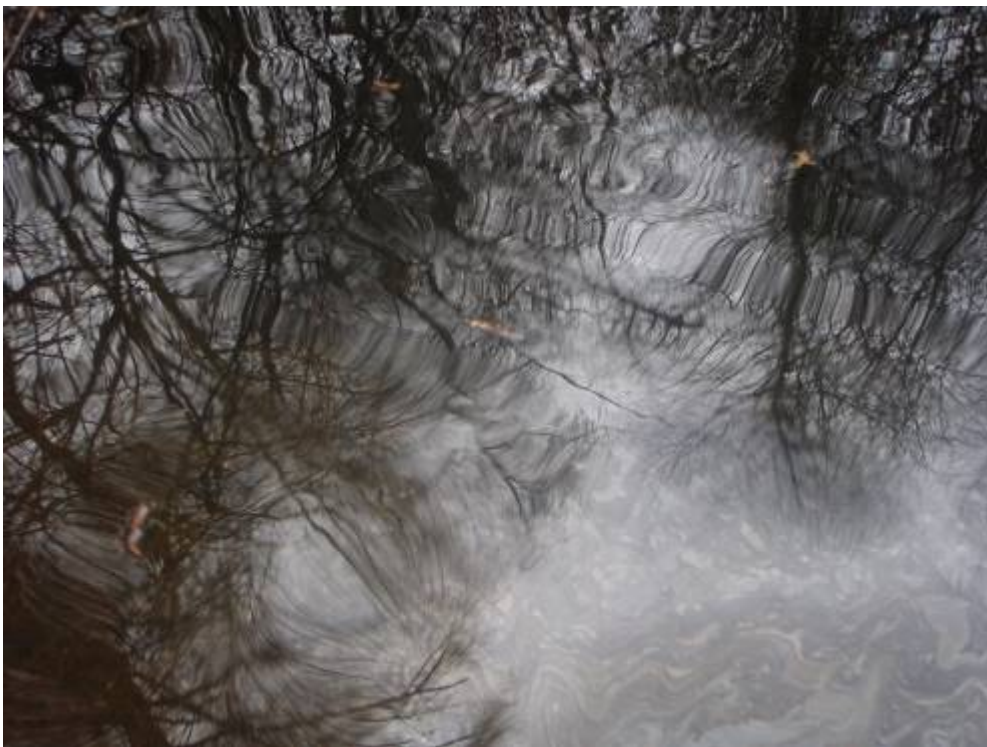
Photo 18 Oily sheens were observed on some sampling dates, especially at MacKay Site 1 (in photo), downstream of Marine Drive.

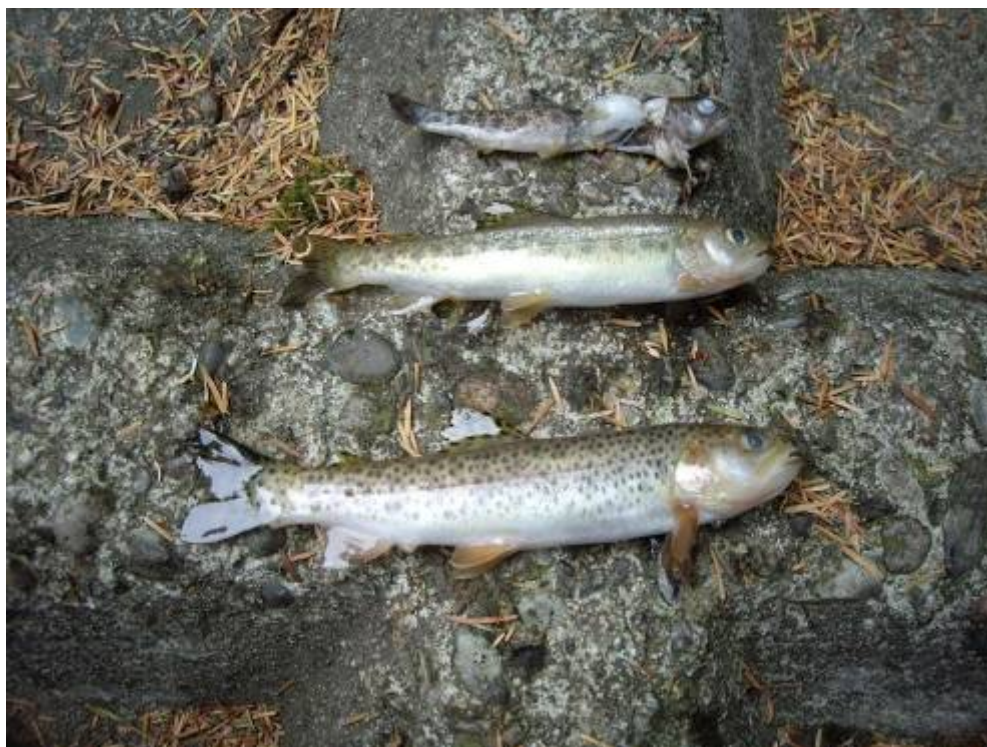
Photo 19 Evidence of a fish kill on a North Vancouver stream. Fish kills result from the discharge of toxic substances, including harsh cleaners, swimming pool and hot tub water, wash water from cement work, and other sources, either accidentally or on purpose.

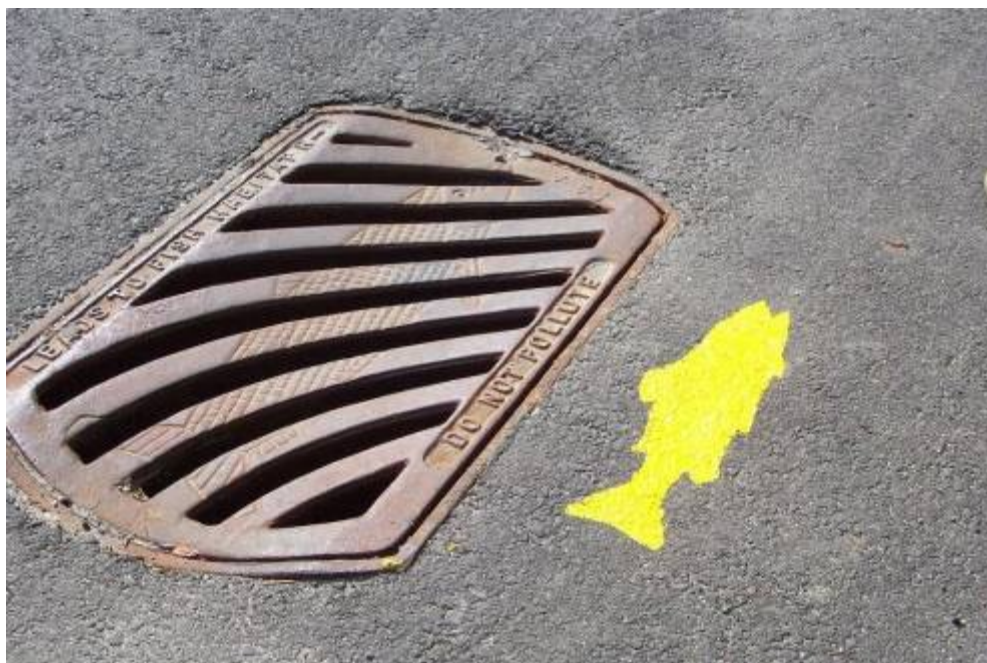
Photo 20 Storm drains lead to fish habitat in streams or the ocean. The storm drain marking program (Fisheries and Oceans Canada) encourages volunteers to paint the yellow fish to remind people about this.
